# Multi-Media Inspection Report

Radford Army Ammunition Plant  
May 16 to 20, 2011

## **Attachment RCRA-I-1: Region III Underground Storage Tank Compliance Checklist**

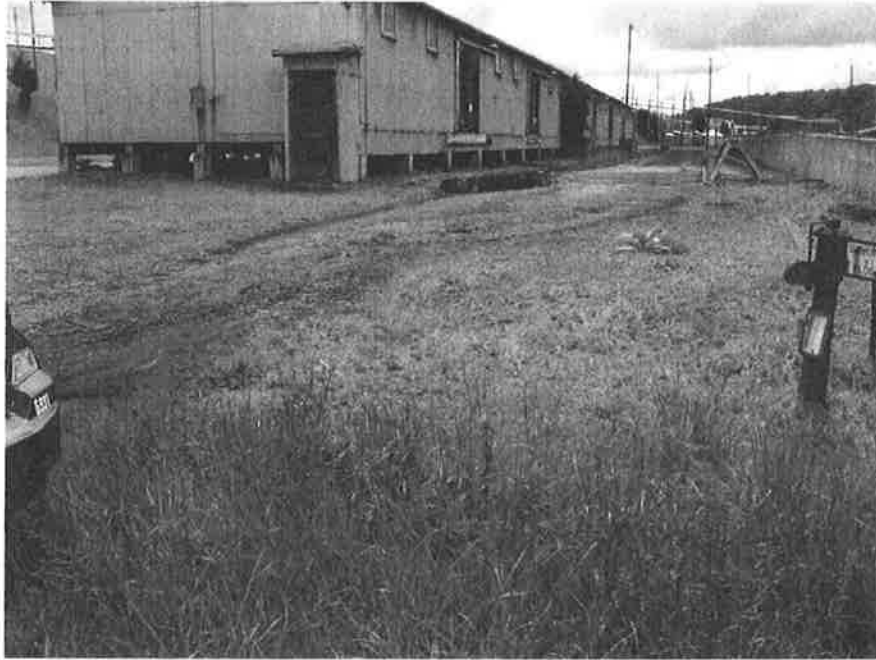
Lime Spill at Coal Pile East End Rail Spur

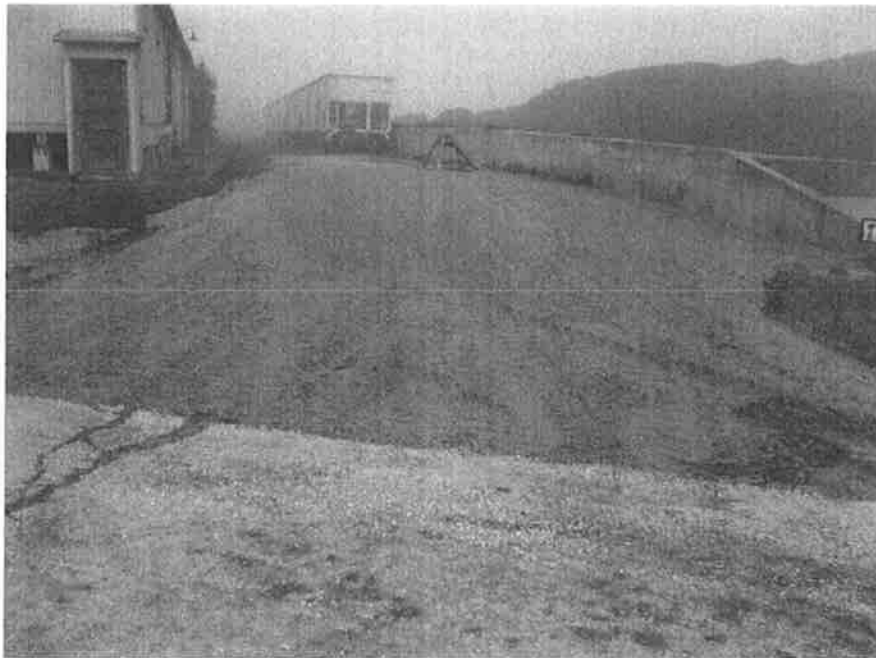
Cleaned Lime Spill at Coal Pile East End Rail Spur

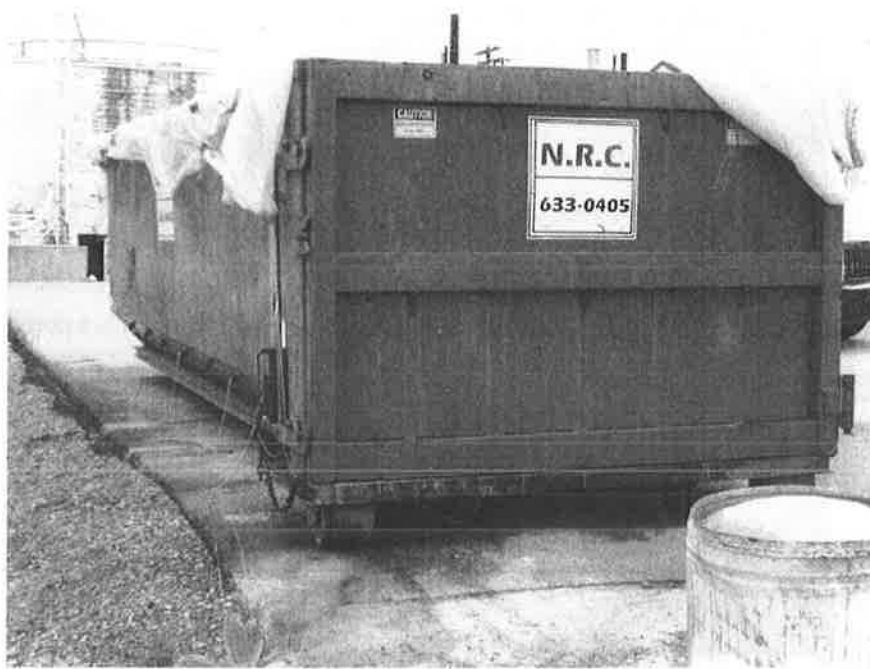
Uncovered Roll-off Box at the AB Waste Acid Treatment Plant

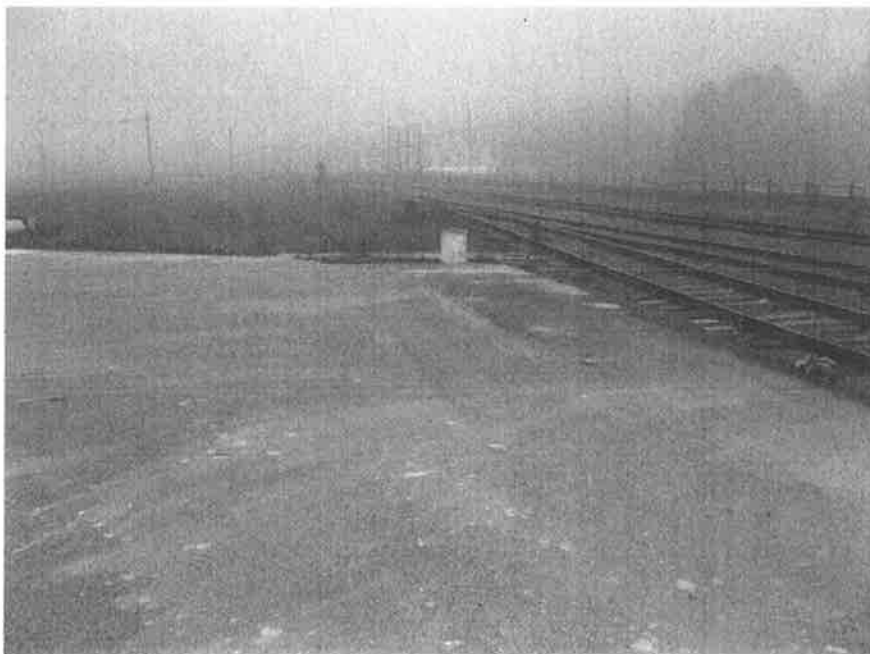
Removed Uncovered Roll-off Box at the AB Waste Acid Treatment Plant

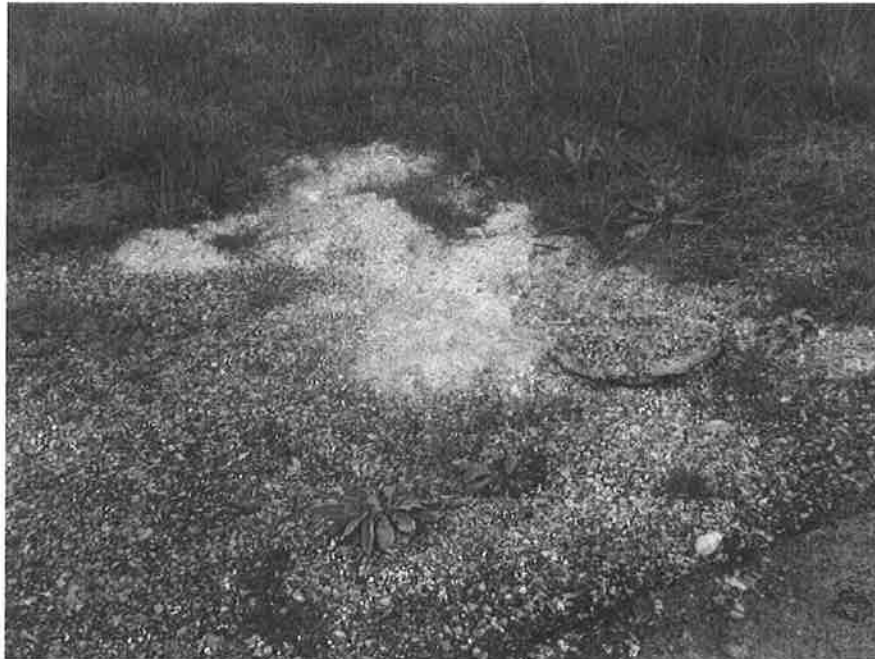
**Lime on the Ground at the AB Waste Acid Treatment Plant**

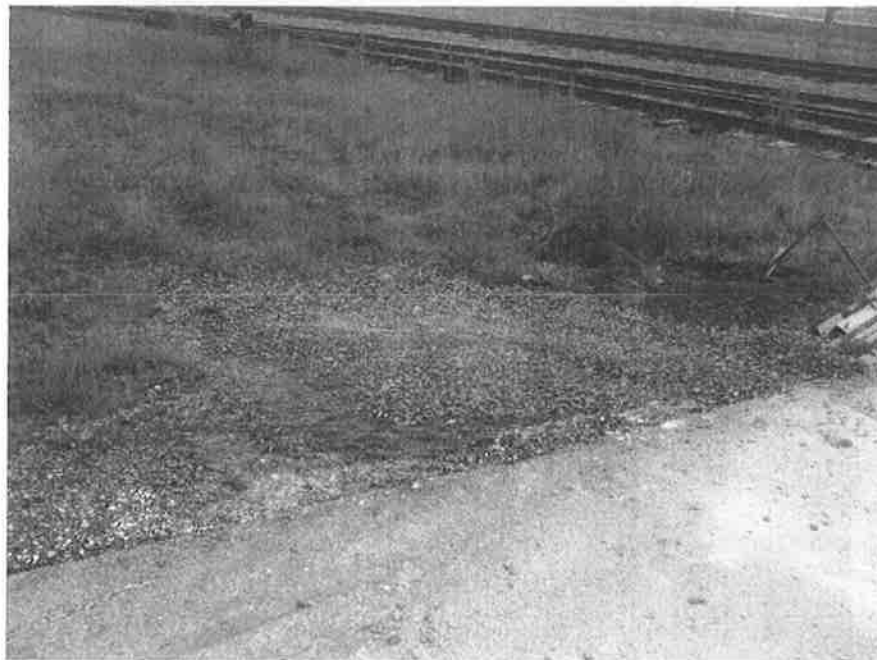
**Cleaned Lime Spill at the AB Waste Acid Treatment Plant**

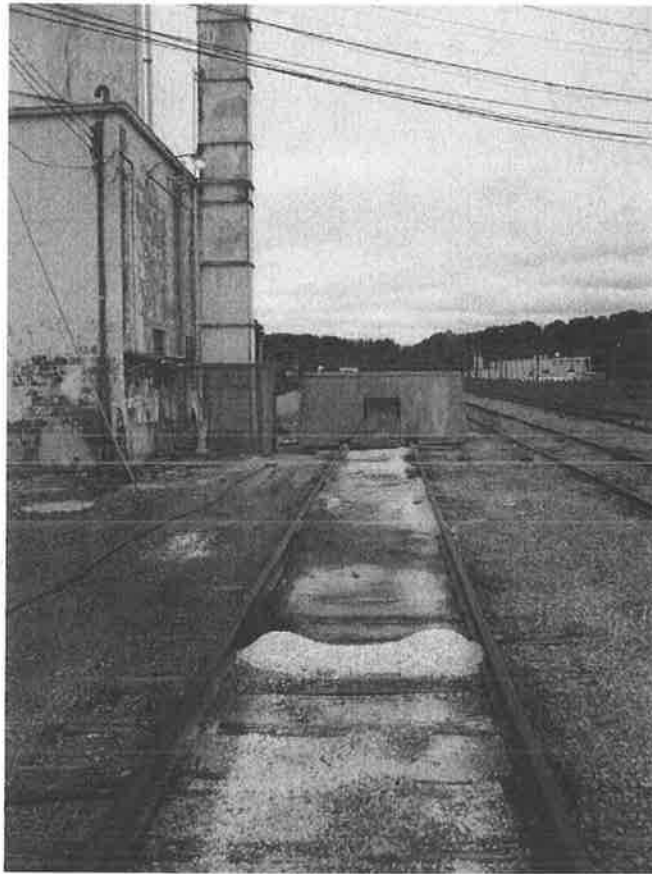
Spilled Lime on the Ground at the AB Waste Acid Treatment Plant Lime Unloading Spur

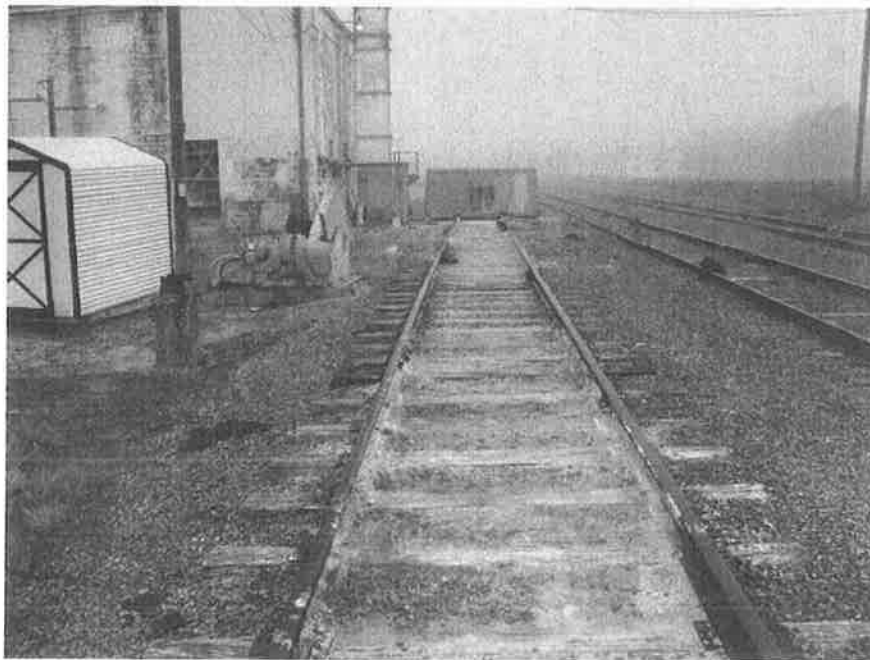
Cleaned Lime Spill at the AB Waste Acid Treatment Plant Lime Unloading Spur

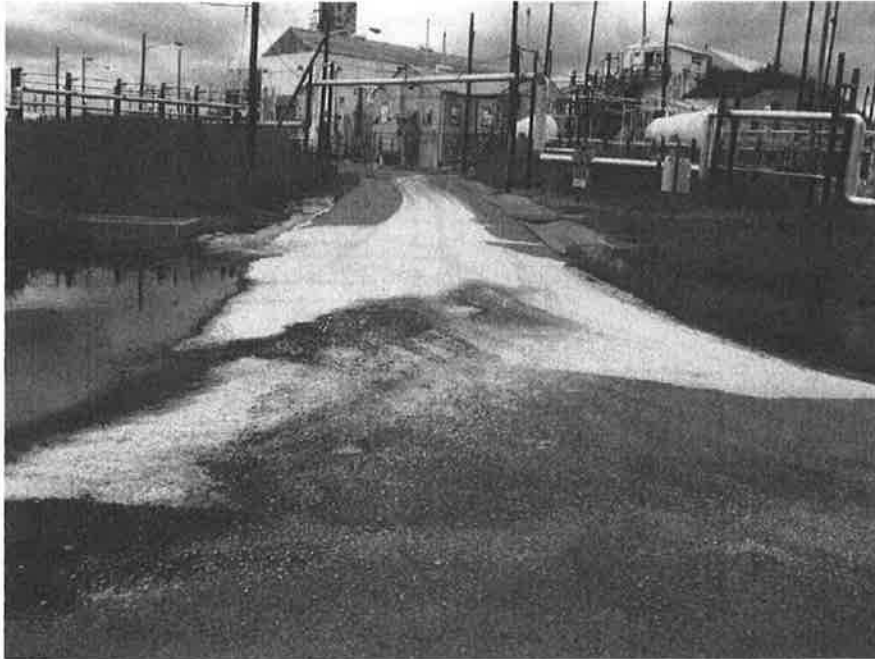
Caustic Soda Ash Spill at the NG2 Area (1 of 2)

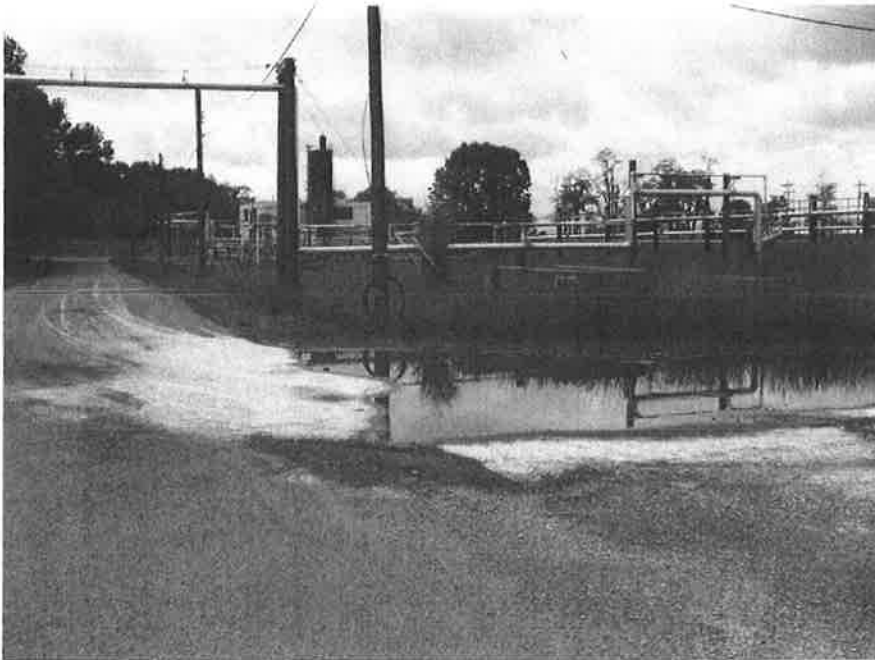
Caustic Soda Ash Spill at the NG2 Area (2 of 2)

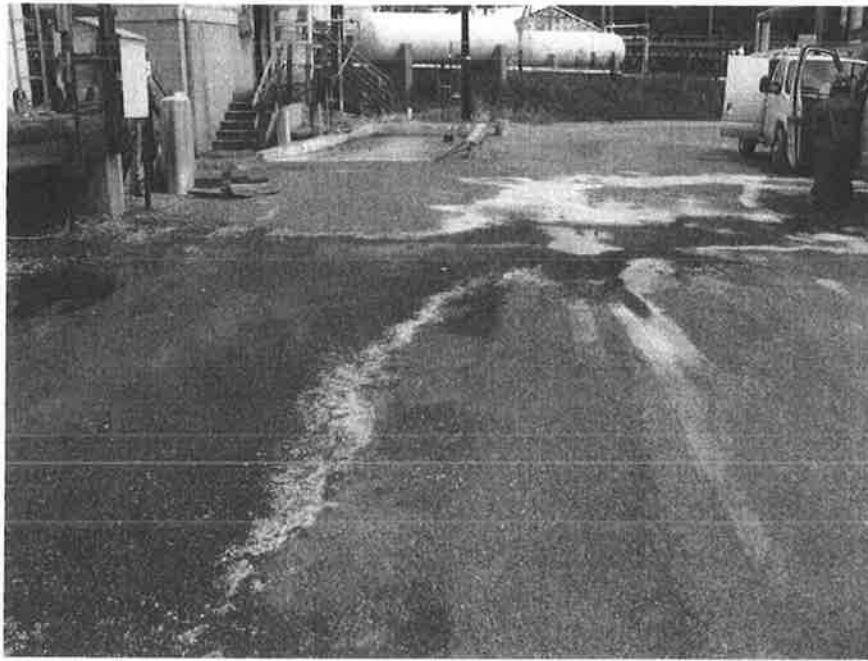
<b>Problem:</b>	Caustic water spilled into roadway		
<b>Why?</b>	Caustic water was leaking from 9465		
<b>Why?</b>	Water leaking out hole in building (hole is at point where the wall meets the floor)		
<b>Why?</b>	Water did not drain well from building		
<b>Why?</b>	Building does not have adequate drainage	Water was from wash down	
<b>Why?</b>			
<b>Why?</b>

Approximate Location where Caustic Soda Ash Spill may have Originated

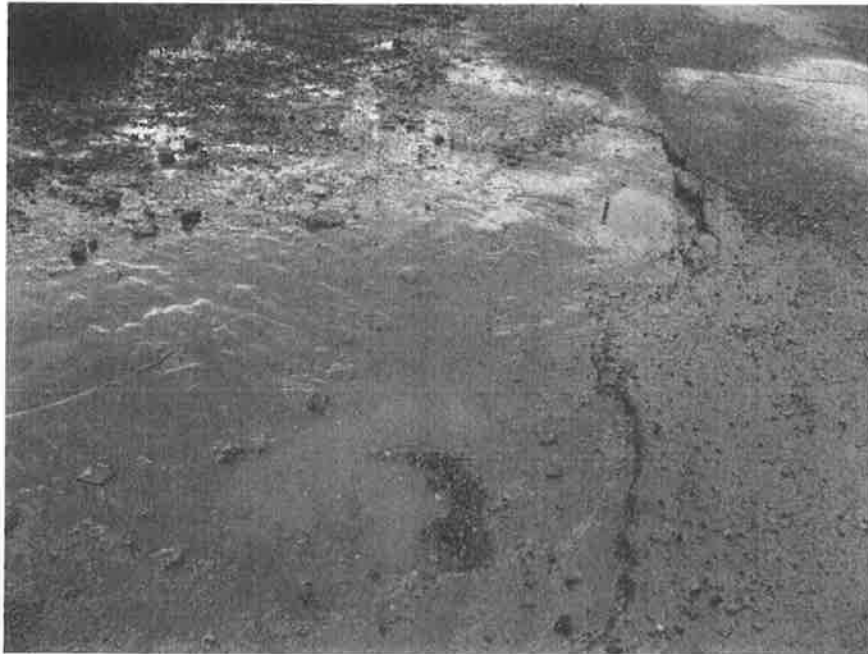
Cleanup of Soda Ash Spill (1 of 6)

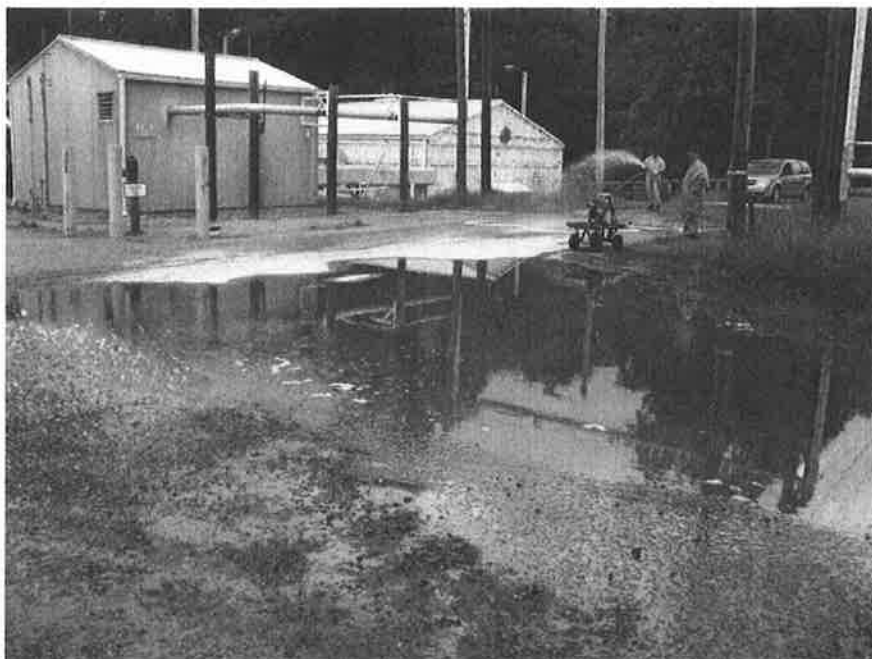
Cleanup of Soda Ash Spill (2 of 6)

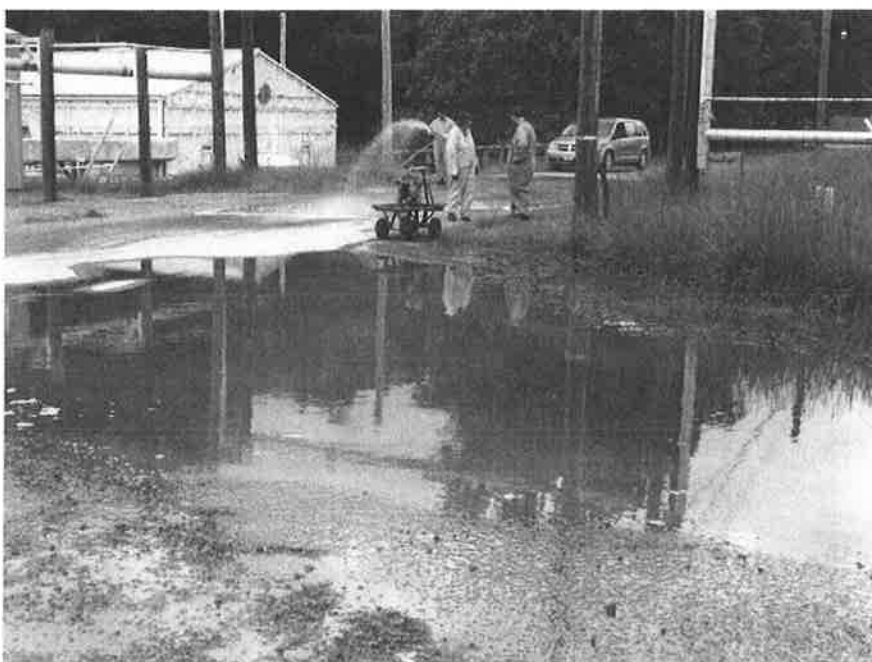
Cleanup of Soda Ash Spill (3 of 6)

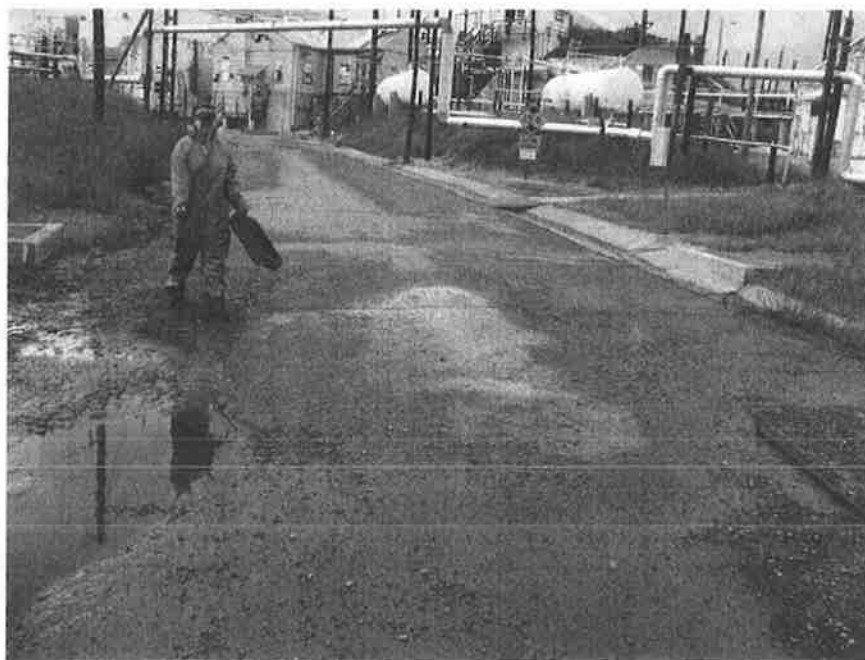
Cleanup of Soda Ash Spill (4 of 6)

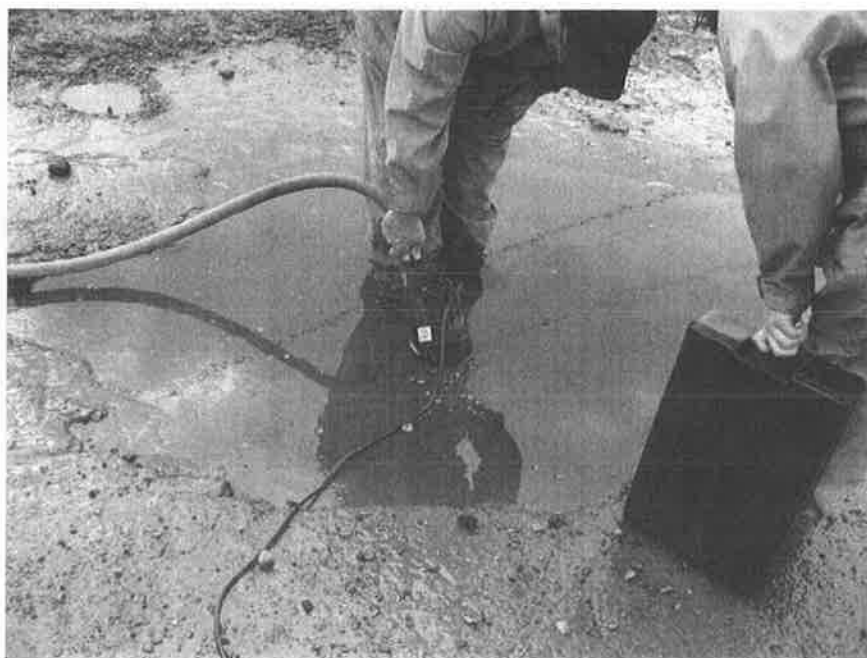
Cleanup of Soda Ash Spill (5 of 6)

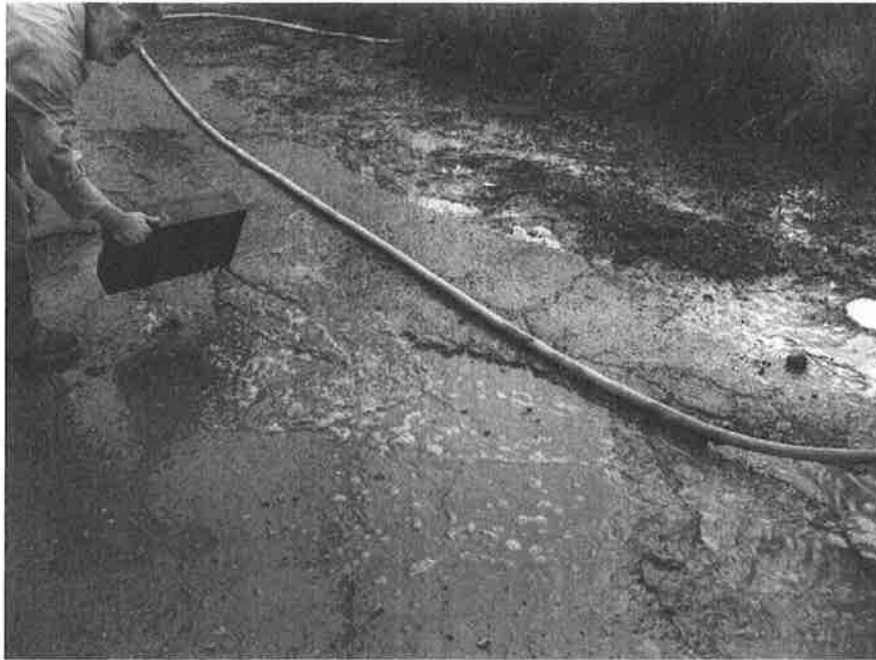
Cleanup of Soda Ash Spill (6 of 6)

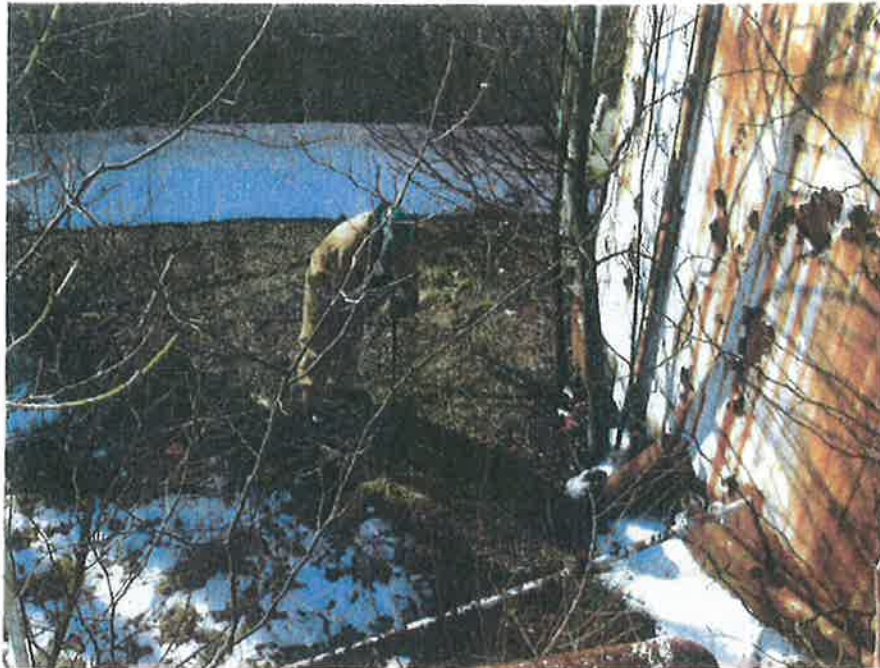
**Photograph 1: Installation of soil boring, SB-3 on March 5, 2009.**

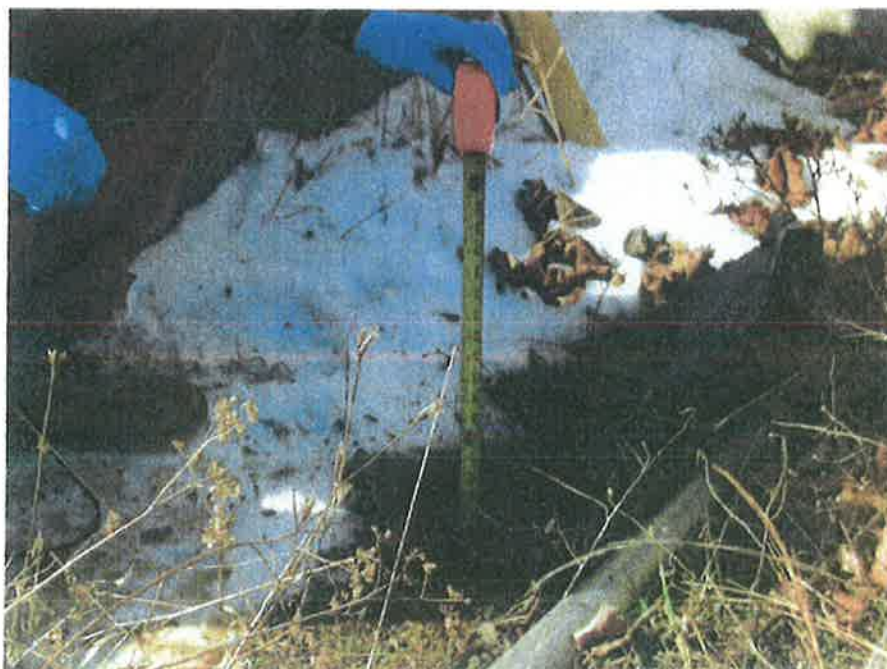
**Photograph 2: Corresponding depth at SB-4 following installation on March 5, 2009.**

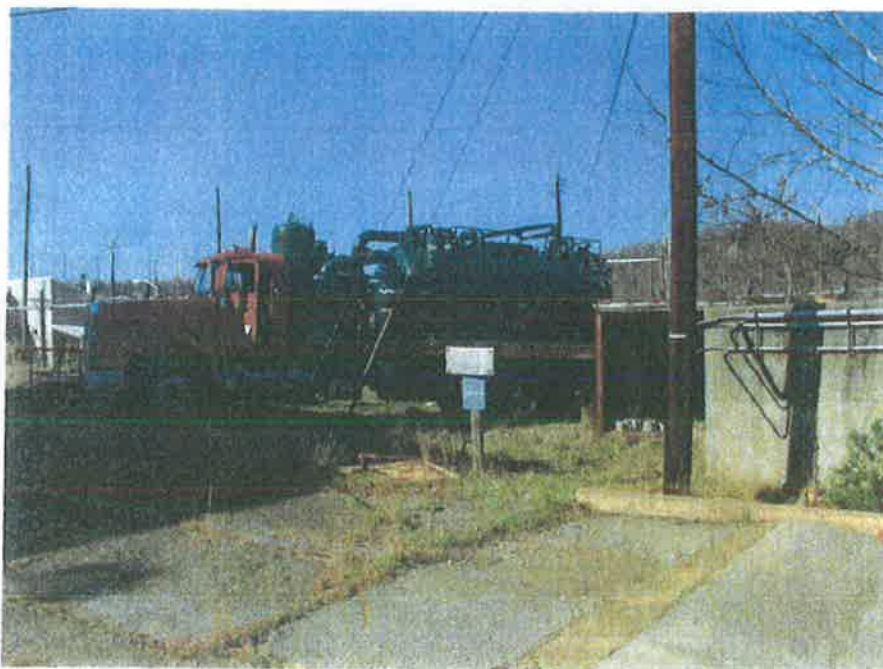
**Photograph 4: Vacuum truck utilized to remove AST rinsate & petroleum residuals.**

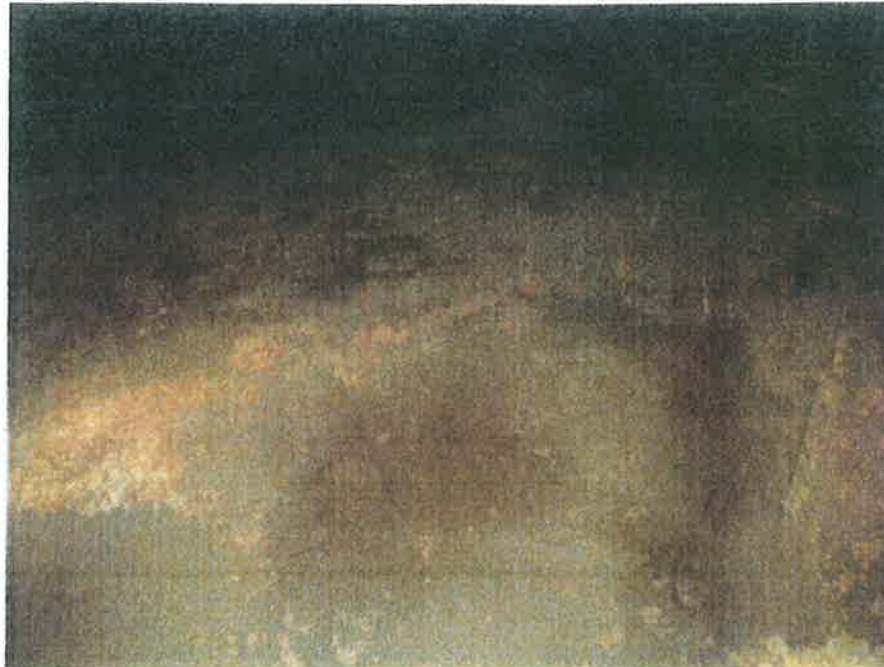
**Photograph 5: Interior floor of AST following cleaning & rinsate removal.**

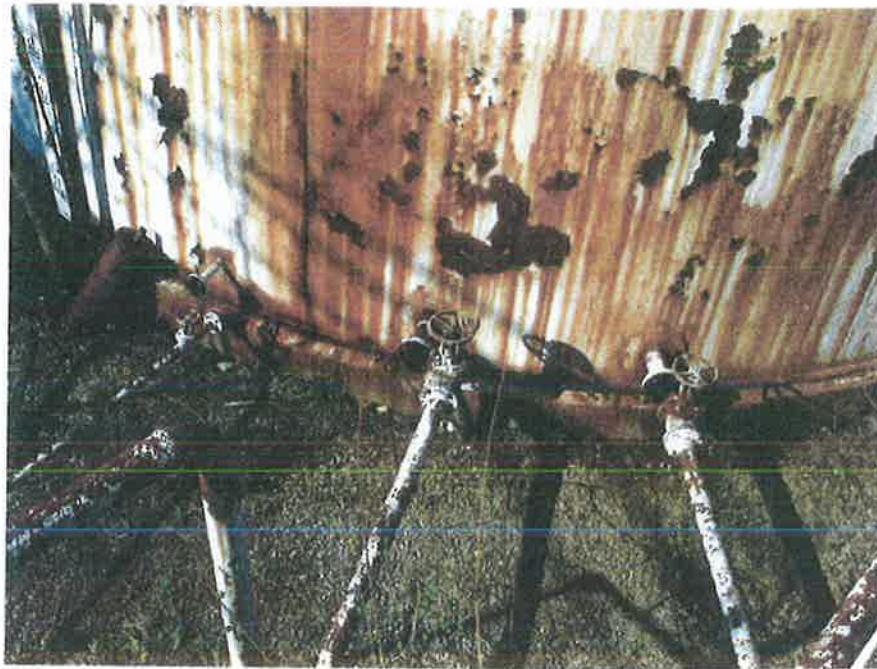
**Photograph 7: Aboveground piping disconnection and locations of the blank flanges.**

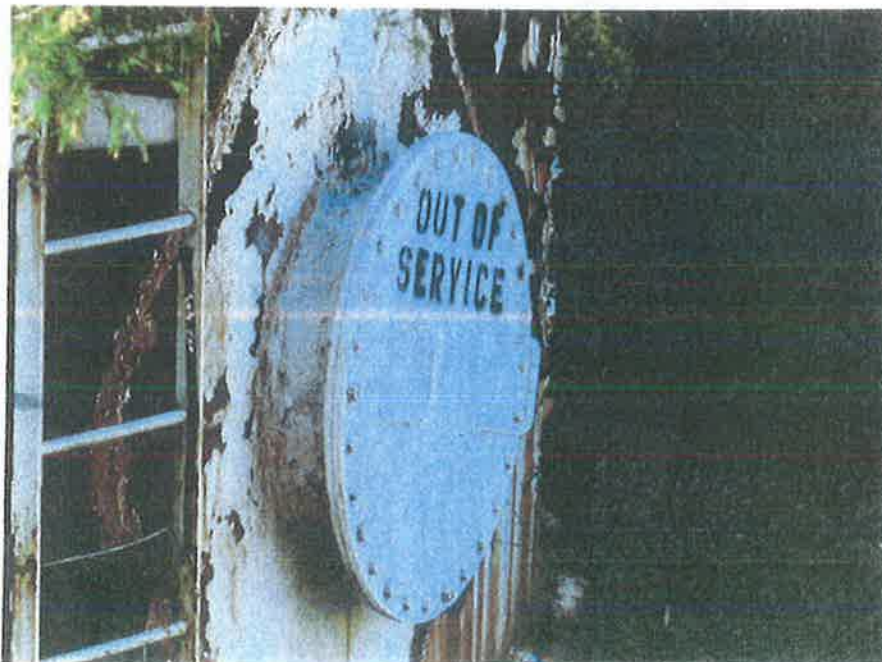
**Photograph 8: Bolted shut and labeled AST entry manway.**

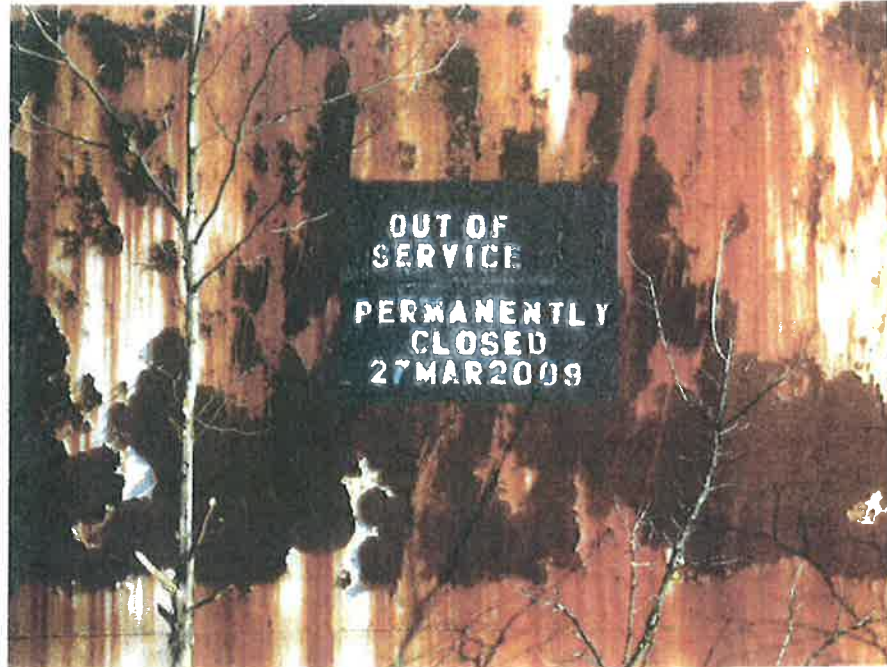
**Photograph 9: Labeling denoting that AST is permanently closed, including the date of closure.**
